CAA Inspection Report

Inspection Date(s): July 17, 2018

Facility Name: Tallaboa Industrial Park

Asbestos NESHAP – 40 CFR 61 Subpart M

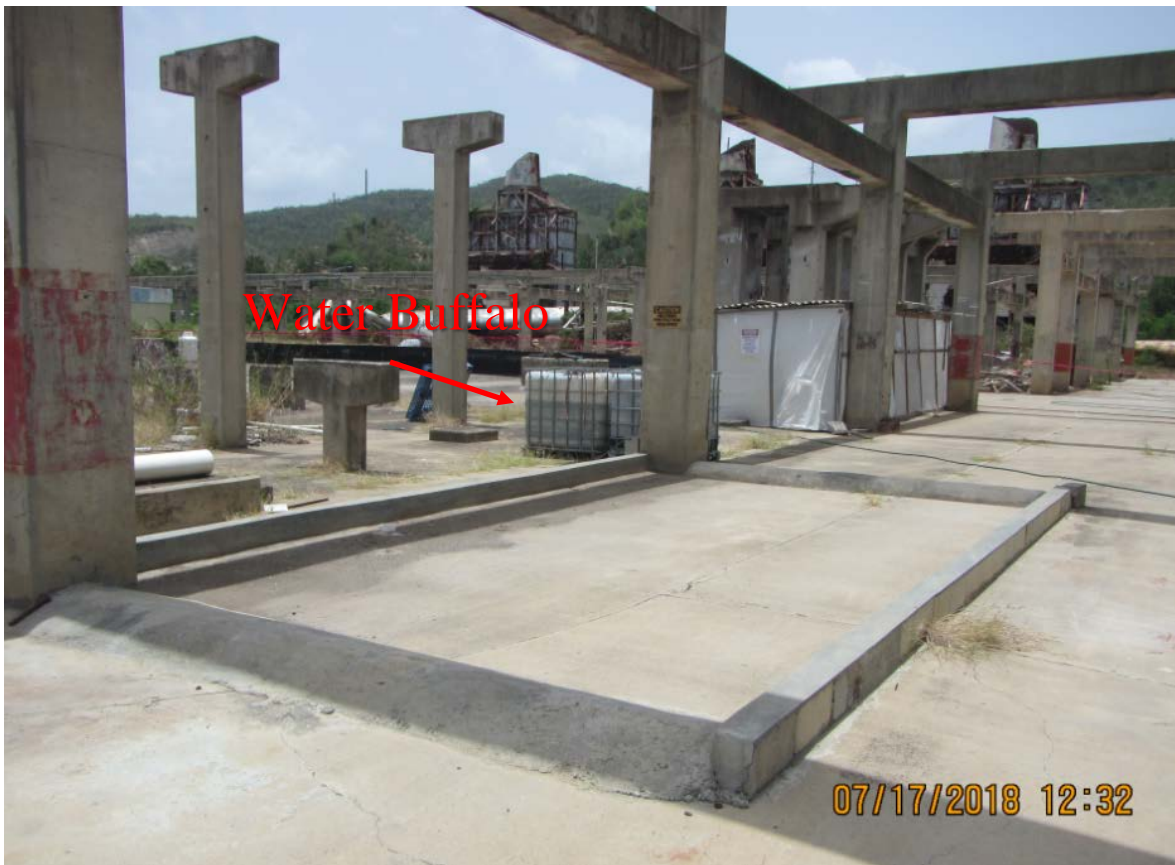
At approximately 12:20 PM, Inspector requested to see the setup for the air monitoring. Mr. Cintron brought the inspector to the trailer that was setup to analyze the filters from the air monitors. The inspector met Jose Santo, the lab technician, from Altol Environmental. He is assigned to setup the air monitoring and personal monitors. The microscope is setup in the trailer on-site which allows him to provide the results to Homeca the day after the air monitoring sample is taken (12 hour-turnaround). On the way back to Homeca's office, Mr. Cintron showed the inspector the personnel decontamination area and the vehicle cleaning area. A cement berm was established to contain water that is used to clean vehicles leaving the Homeca work area. The water is then pumped and filtered before going into the "two water buffalos" as seen in figure 5. At the time of the inspection, no air monitoring station was noted outside the personnel decontamination station.

Fig 5, Passage way into the Homeca site. A berm station was setup for vehicle cleaning. Two water buffalo is setup to collect filtered water collected from the vehicle cleaning. A decontamination station was also seen in the picture. Passage has been cleaned so that they can drive trucks into the site.

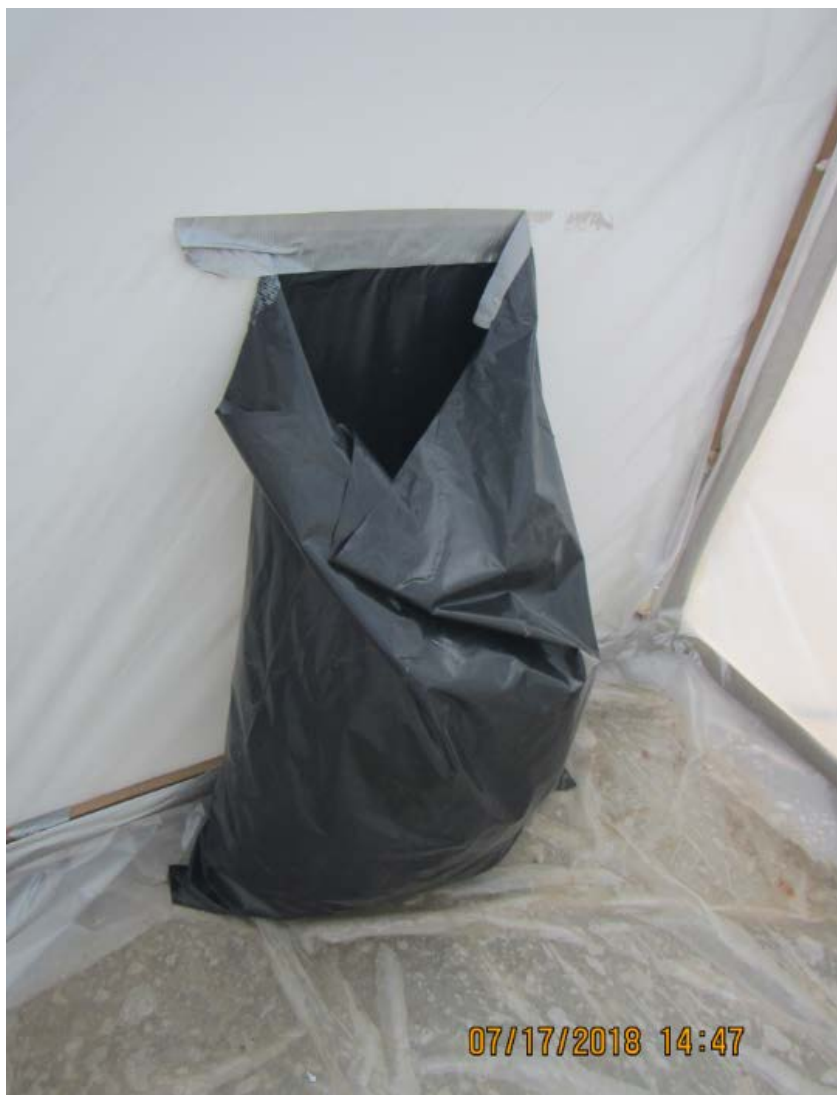
Figure 6, Inside the decontamination station, an unlabeled bag that was used in the contaminated space for used personal protective clothing and filters.

decontamination shower. The bag that was not labeled with the proper labels (see figure 6) was replaced with properly labeled bags.

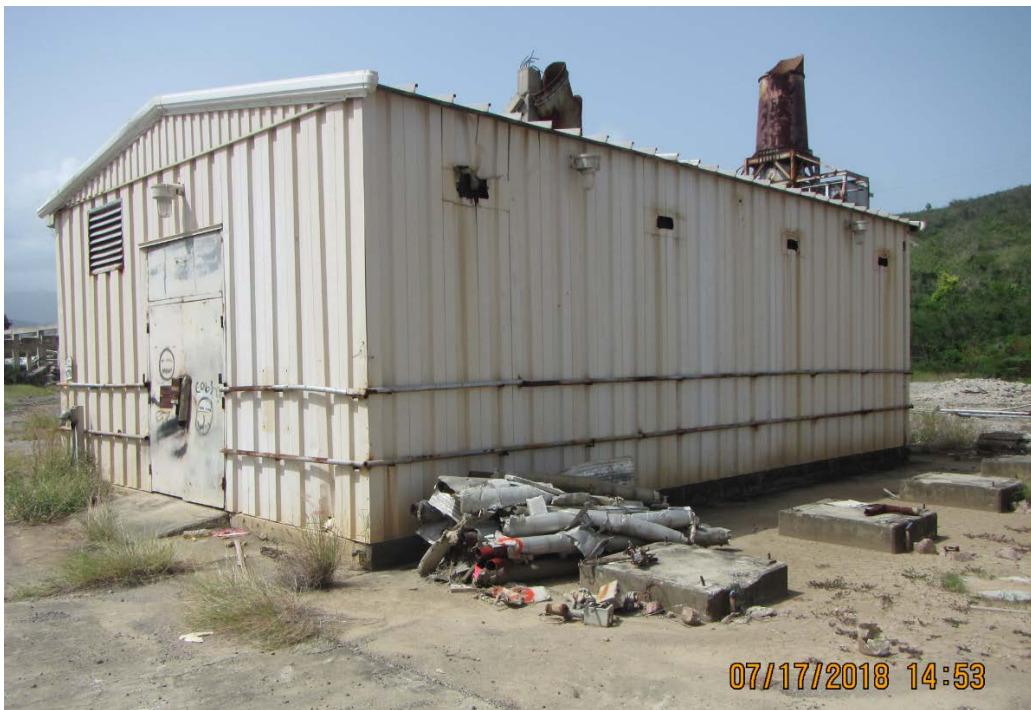
The inspector walked into the site and turned right. Soon after making a right turn from the decontamination station, the inspector noted that pipes with insulation laying outside a locked shed (see figure 7). Mr. Feliciano stated that he did not know where these pipes came from. The material was not wrapped and not wet. There was no equipment (water sprays) that would maintain the material wet at all times. The inspector asked if he can get into the locked shed. Mr. Feliciano stated that Homeca does not have access to the locked shed.

Figure 7, Pipes with insulation that was found outside a locked shed. Homeca staff stated that they did not have access to the shed. Homeca staff also stated that they were not aware how the pipes with insulation got there. The material was not wrapped and not wet.

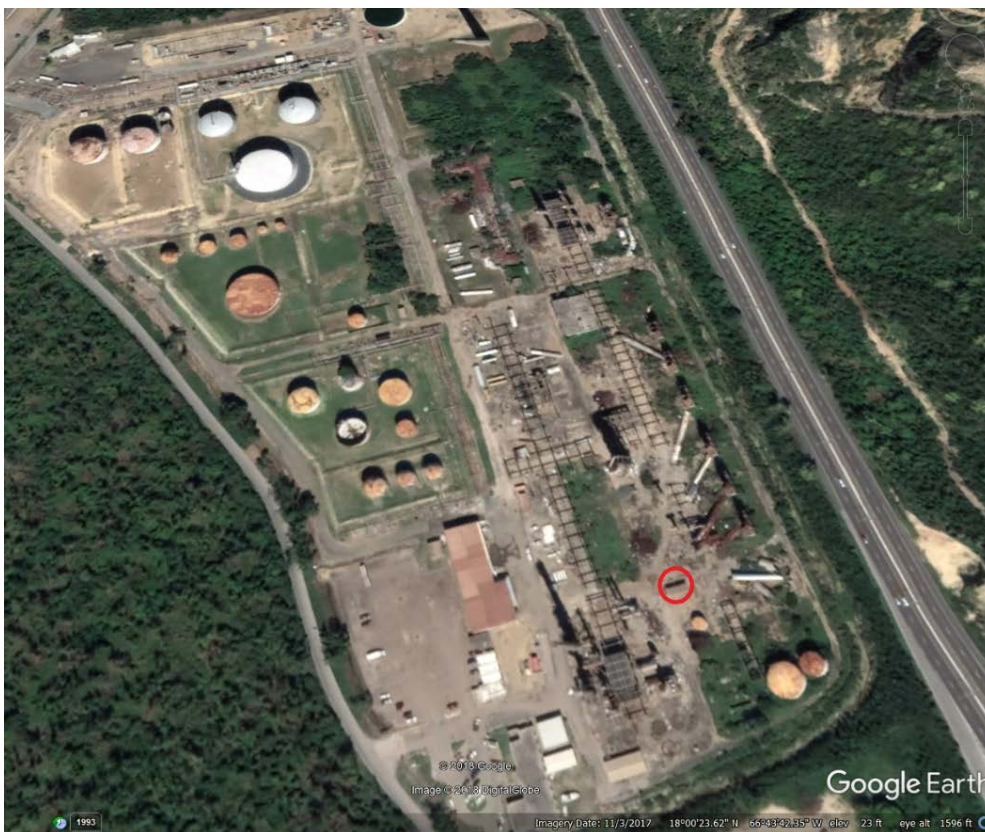
Figure 8, location where pipes with insulation was found as noted in figure 7.

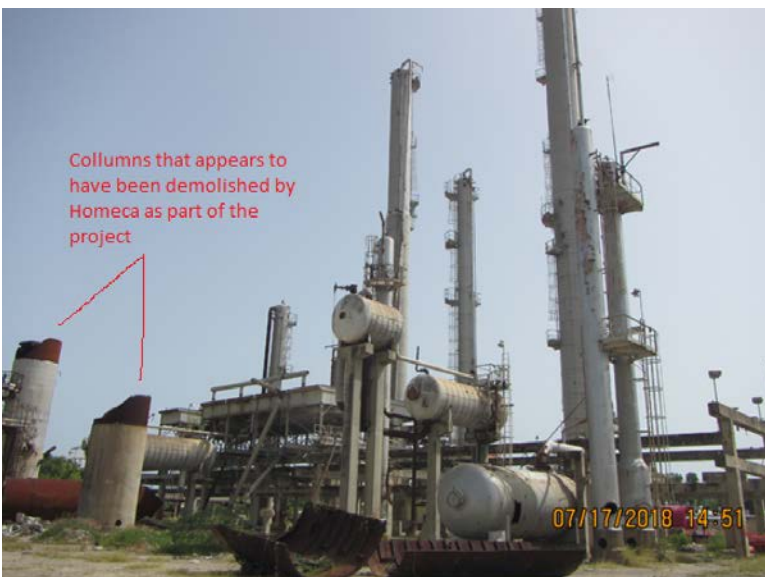
during this inspection (figure 10), it appears that Homeca also partially demolished the two columns seen in figure 10. On one of the two columns, insulation material was still on the remaining portion of the column (see figure 11). Nearby to this location, the EPA inspector observed cladding that appears to have fallen from standing structures. Homeca has collected some of these metal scrap into a pile (see figure 12). Insulation blocks resembling the insulation that is still on the column at the time of the inspection (see figure 11) was found scattered throughout the worksite. An example of this is seen in figure 13. Figure 14 shows the deterioration of insulation material after being exposed to the elements. The inspector also saw white circular drops of white material scattered throughout this area. (see figure 13)

Figure 10, Southern End of the work area. Columns and tanks that have relatively intact ACM and aluminum covers. Pipes still appears to have insulation on it. The abatement of the asbestos on these structures are part of

Phase two of the work plan. Comparing figure 3 with figure 10, it appears that the columns identified above were demolished by Homeca as part of this project.

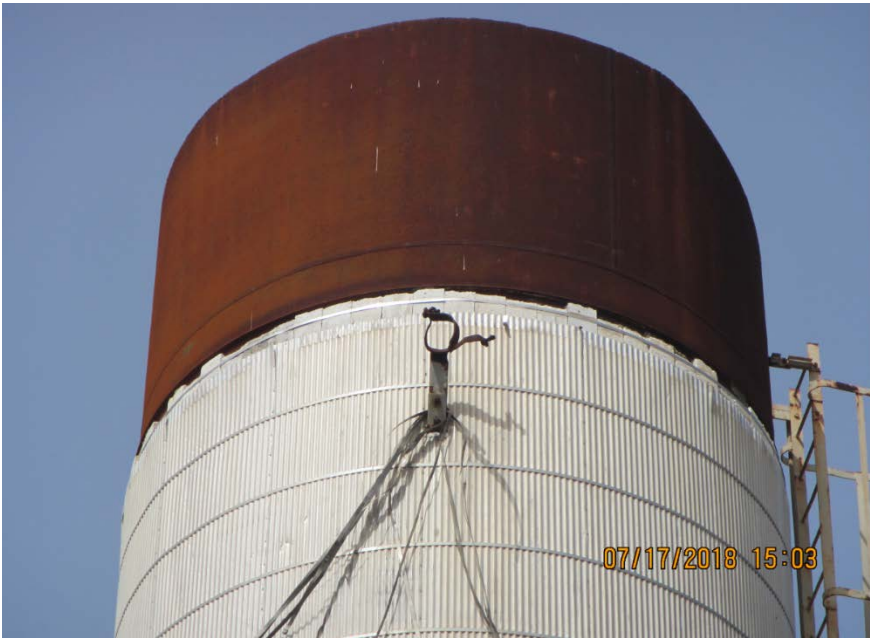
Figure 11, Closeup of the columns in figure 10 where insulation was exposed to the element. Image shows that a large section of insulation and cladding is missing from the structure and deterioration of the exposed insulation.

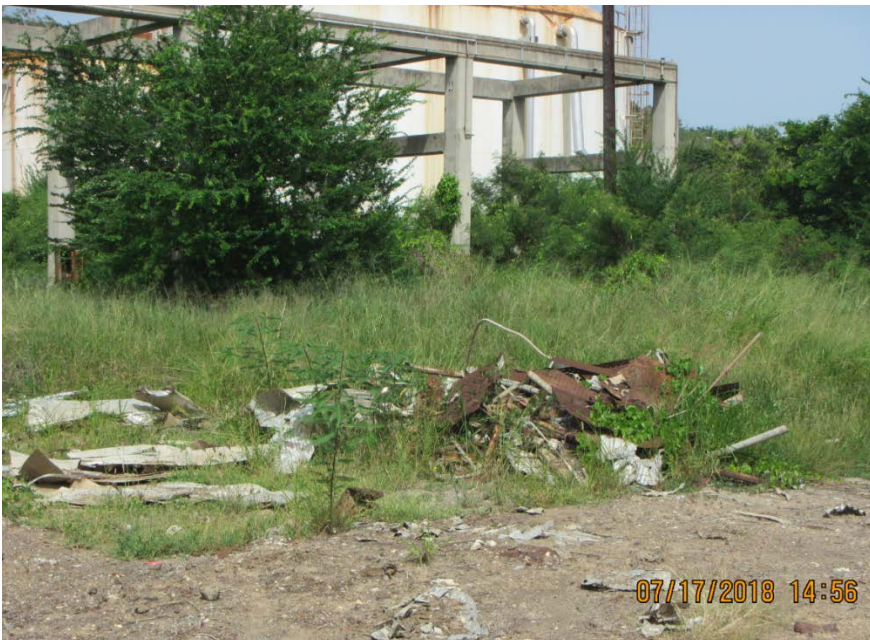
Figure 12, Pile of comingled debris. Pipe with insulation, cladding, pipe wrapping and metal were among the material that were identifiable.

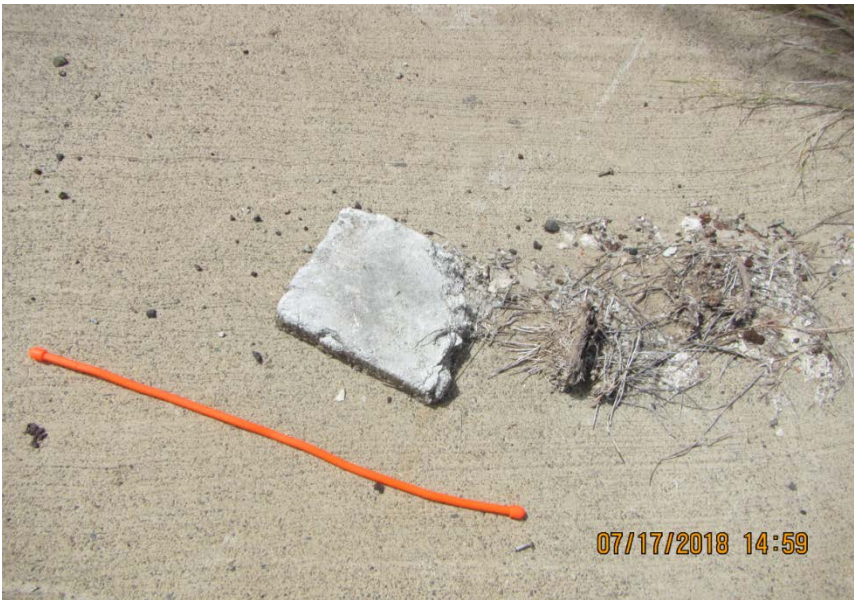
Figure 13, Insulation material which resembles insulation on the larger structures.

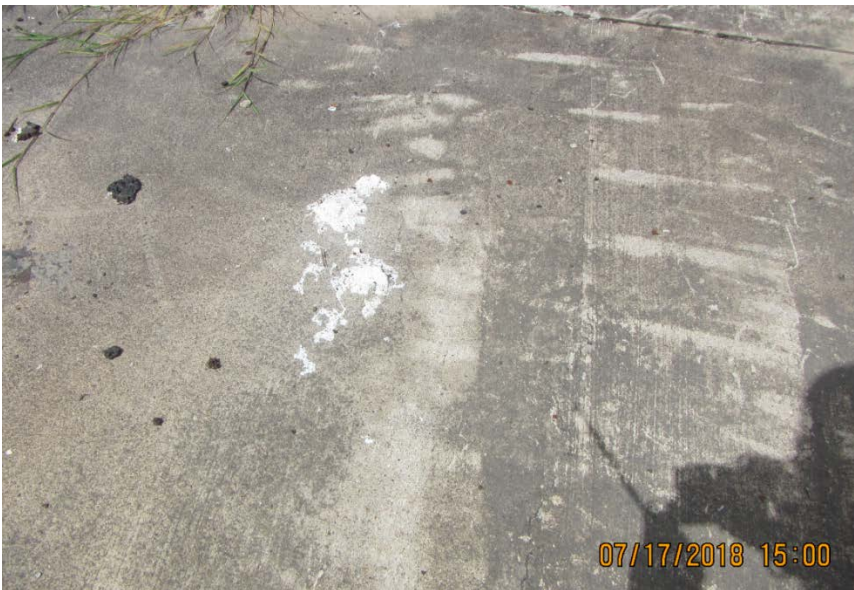
Figure 14, Insulation material that appears to have been exposed to the elements.

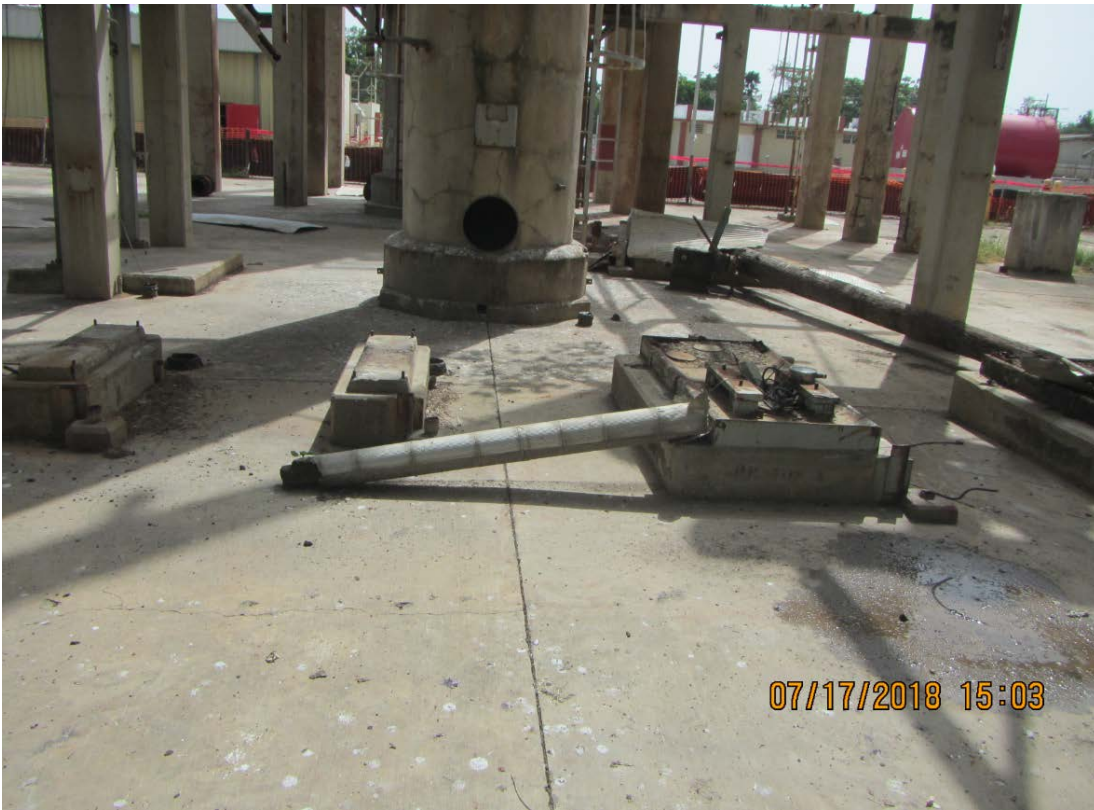
Figure 15, Pieces of deteriorated insulations dropping from standing structures result in white circular dots on the ground. This was seen all throughout the site.

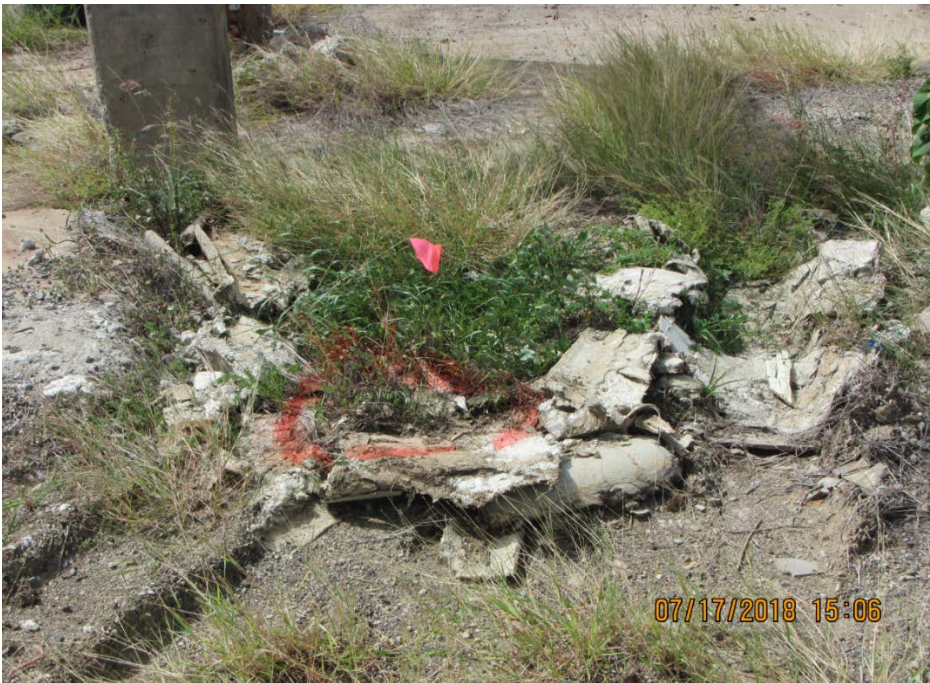
Figure 16, Pipe insulation that appears friable and dried laying in the open.

Pipe insulation was found on the ground in this area (see figure 16). The material appears to be dry and a sample appears to have been taken by Superfund based on the marking. The ground in the area is so dry that cracks developed in the soil (see figure 17).

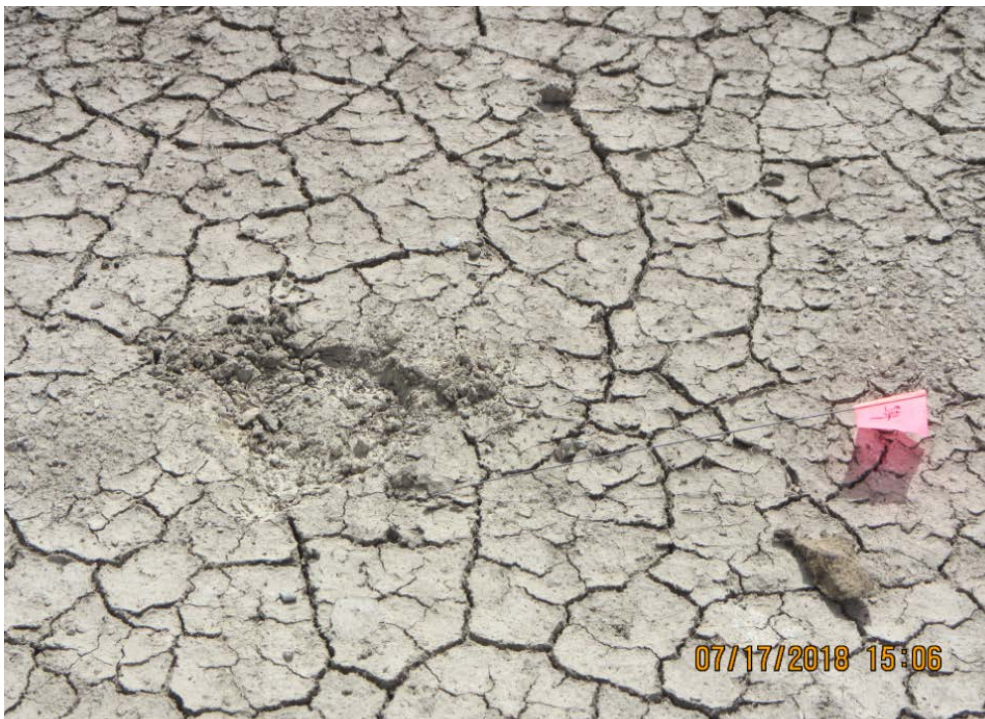
Figure 17, The imprint of a piece of insulation that was taken during CERCLA inspection a few days ago. The cracks in the ground is indicative of how dry the condition is at the site.

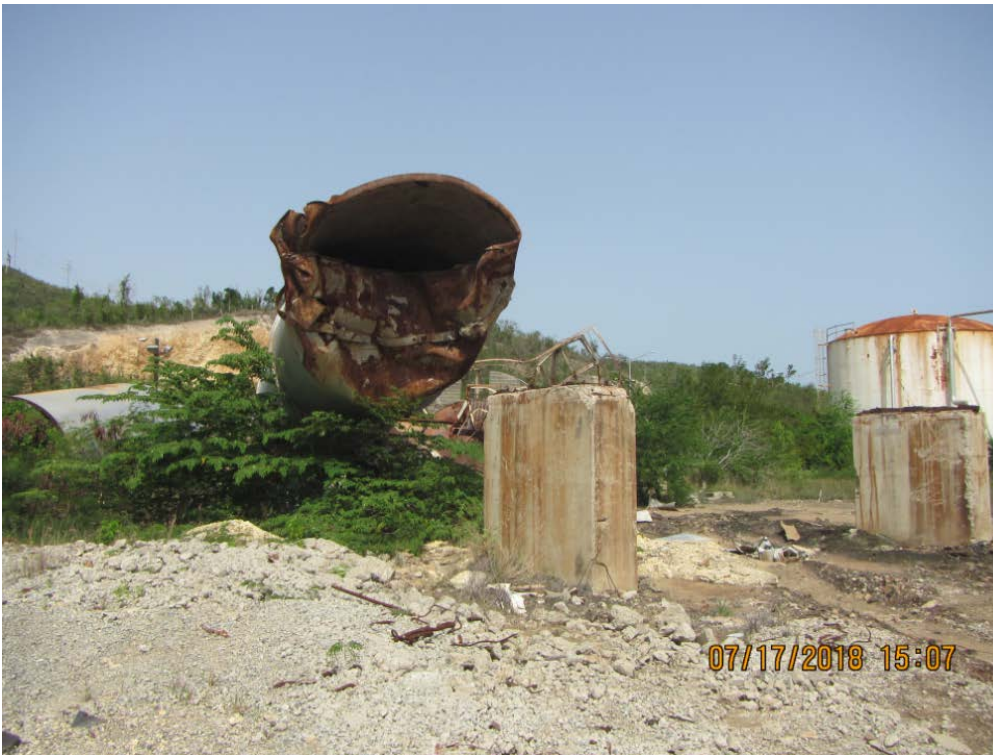
Figure 19, Piles of brick and rubbles from the boiler enclosure demolition. The material was dry with no indication that it has been kept wet. The picture also shows that there is a layer of mortar like lining inside the metal stack.

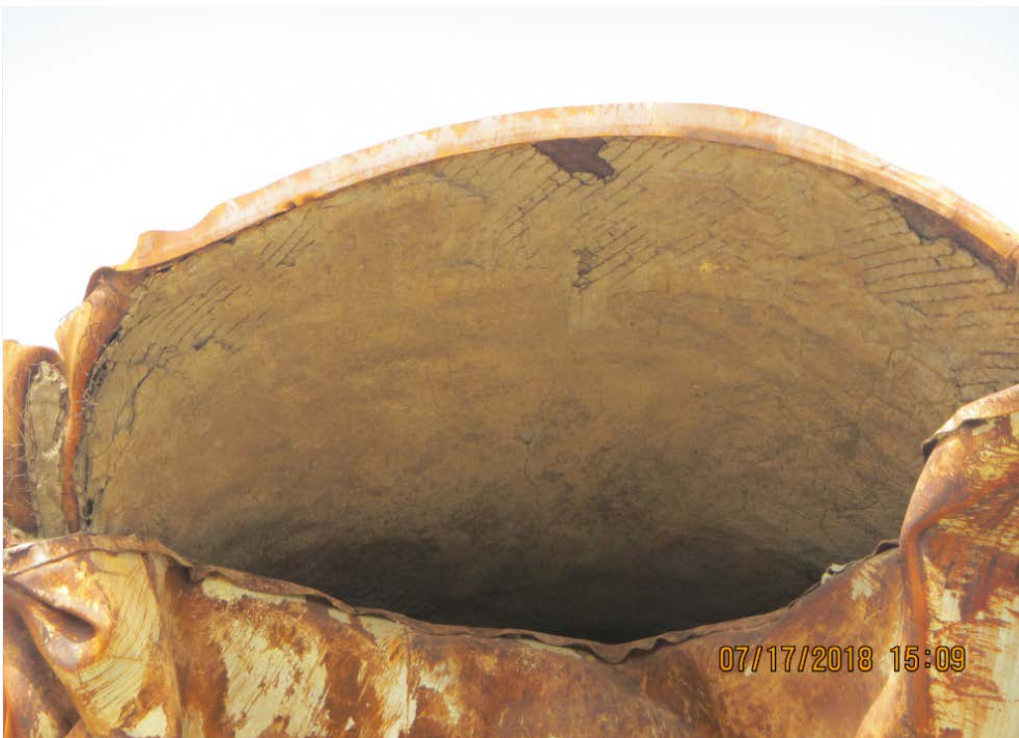
Fig 20, Closeup of the stack opening, it is noted that a thick layer of mortar like lining is present. Part of the lining appears to be damaged and has fallen off.

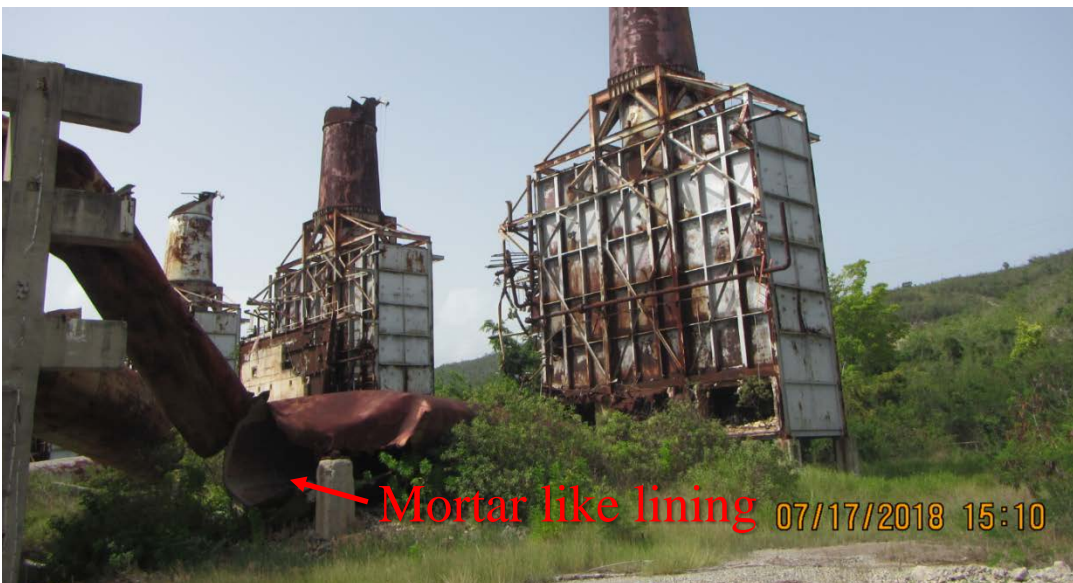
Figure 22, What is left of the metal structure that used to house the boiler. There are six of these structures still standing. The stack appears to be cut in half. It appears that a mortar like lining covers the entire inside of the stack.

While walking through the Homeca work area where the six stacks are originally located, the inspector noted that stack fell on top of the rack as seen in Figure 22. The mortar like lining material still appears to be inside the stack when the stack was demolished. The inspector also noted that some of the bricks used in housing of the boiler are still attached to the standing structures. Insulation material appears to be comingled with the

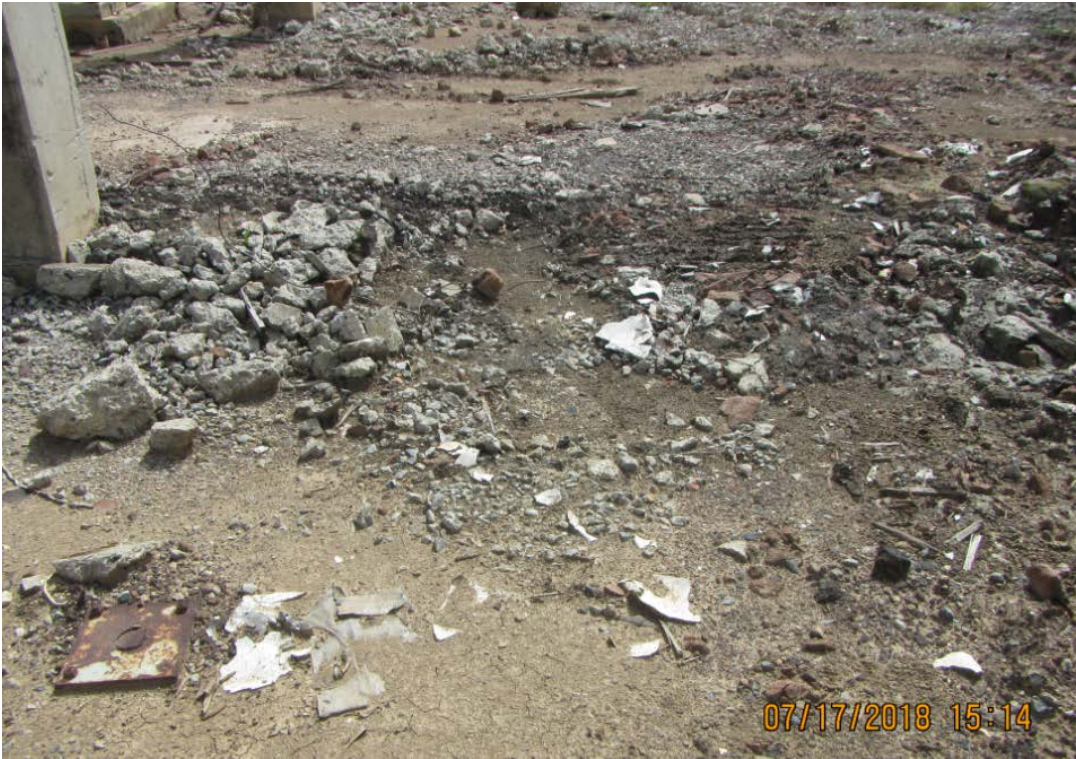
debris (see figure 23). Figure 23 also shows what appears to be construction vehicle tracks which would further break down the insulation material and spread the contamination.

Figure 23, It appears that insulation material has been comingled with the debris pile that from the demolition of the boiler housing.

Insulation material were found in very poor conditions on and in the demolition debris (see figure 23). Insulation material are being found scattered throughout the work area (see figure 24 to 27). The 7 stacks that were demolished by Homeca have been crushed, cut and one case have been cut into numerous smaller pieces (see figure 28 to 30).

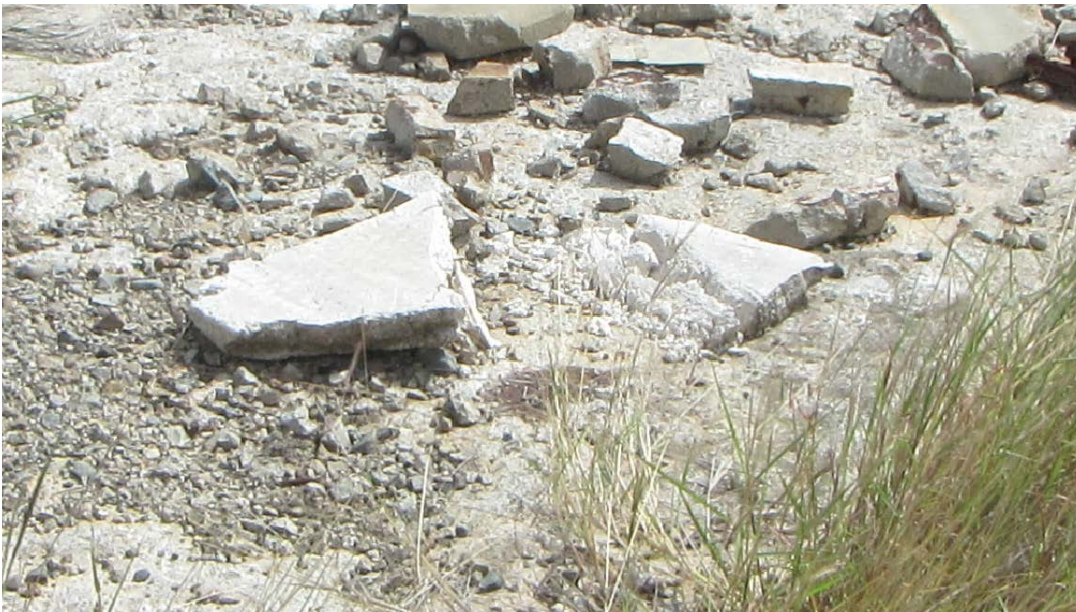
Figure 24, Insulation Material on a concrete debris. The material appears to be powdery and dry.

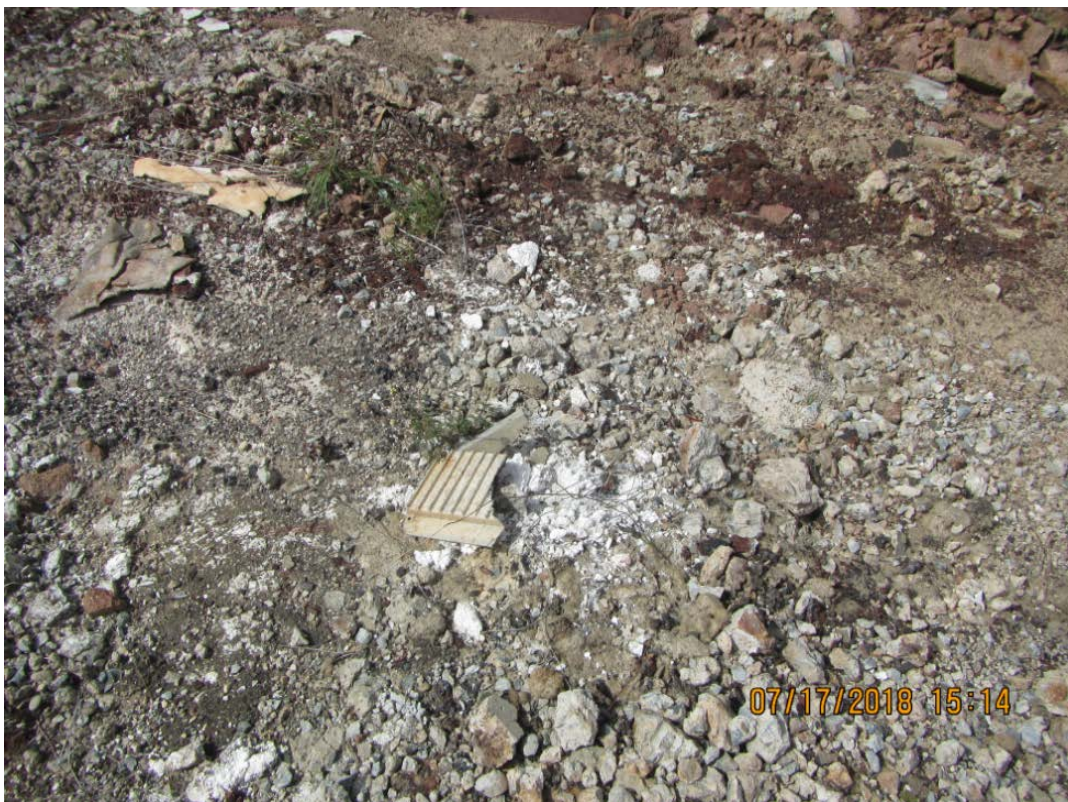
Figure 26, Further shows extent of contamination of the demolition debris.

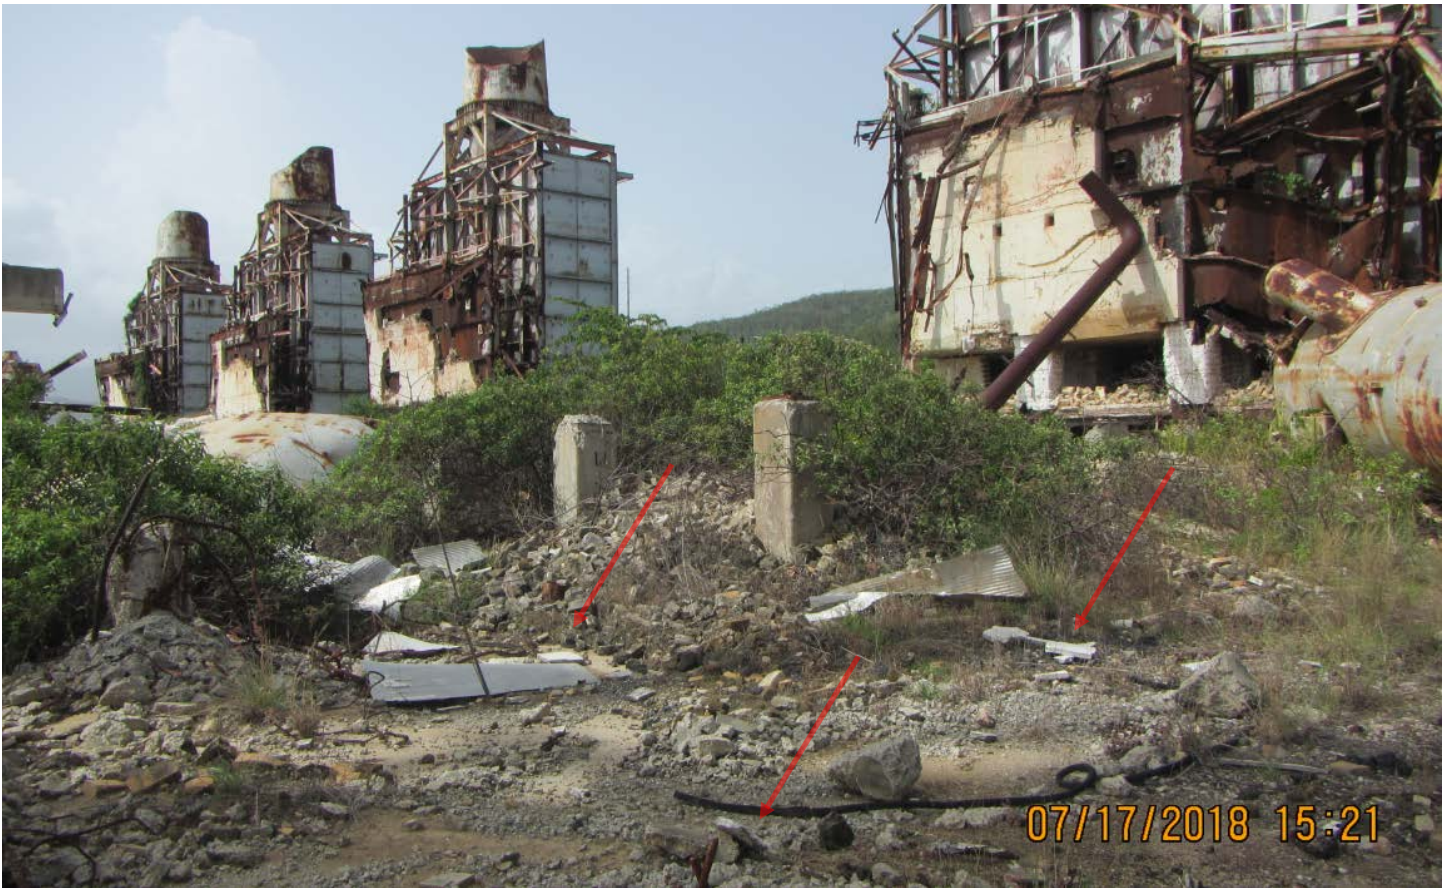
Figure 27, Debris pile that was not totally covered by vegetation. There are aluminum cladding and blocks of insulations visible in and around debris piles.

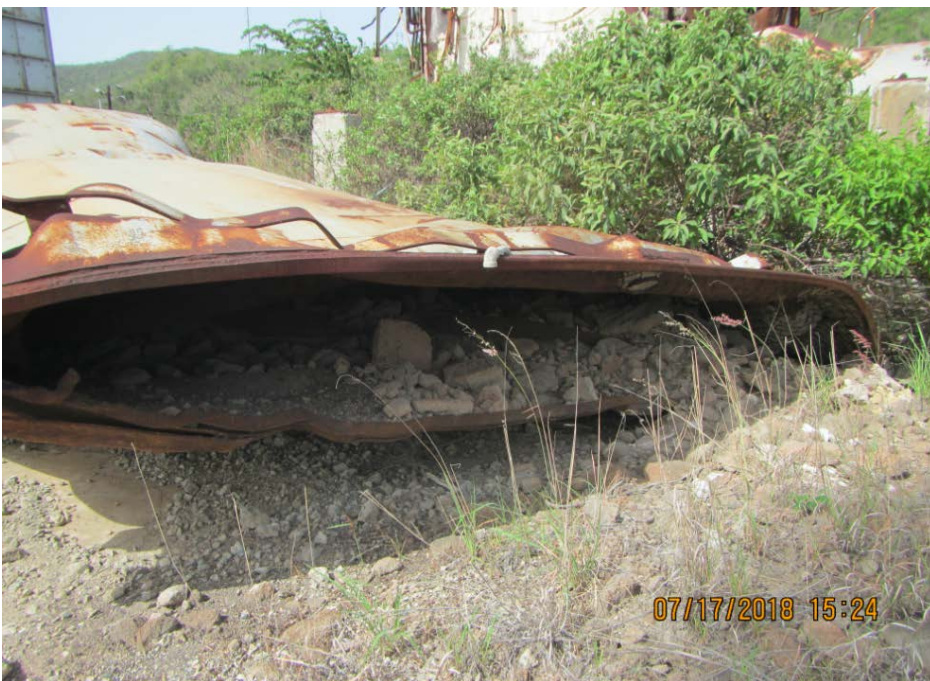
Figure 28, Stack appears to be flatten with lining material still inside.

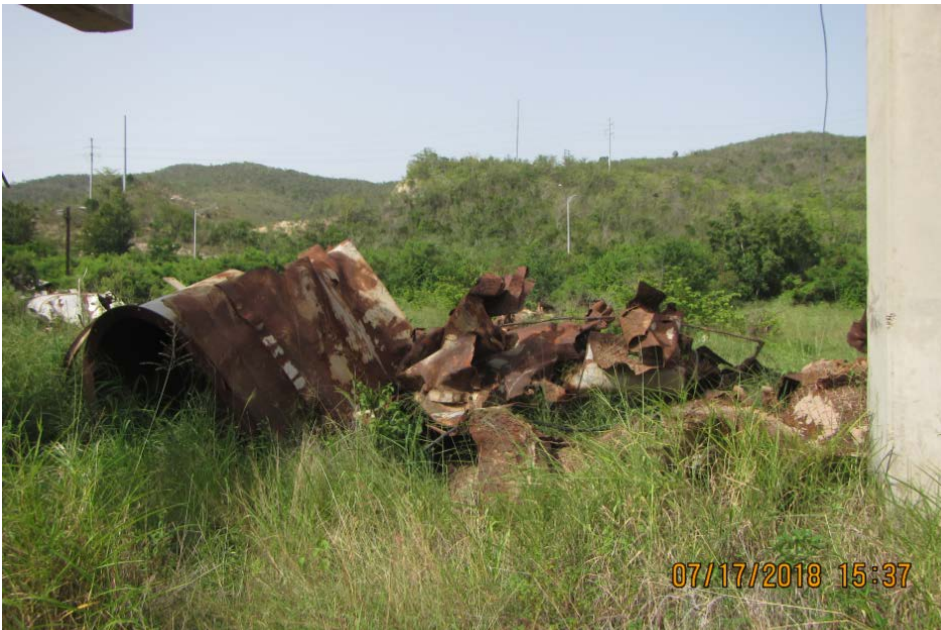
Figure 29, Metal stack appears to be shredded with the lining still in place.

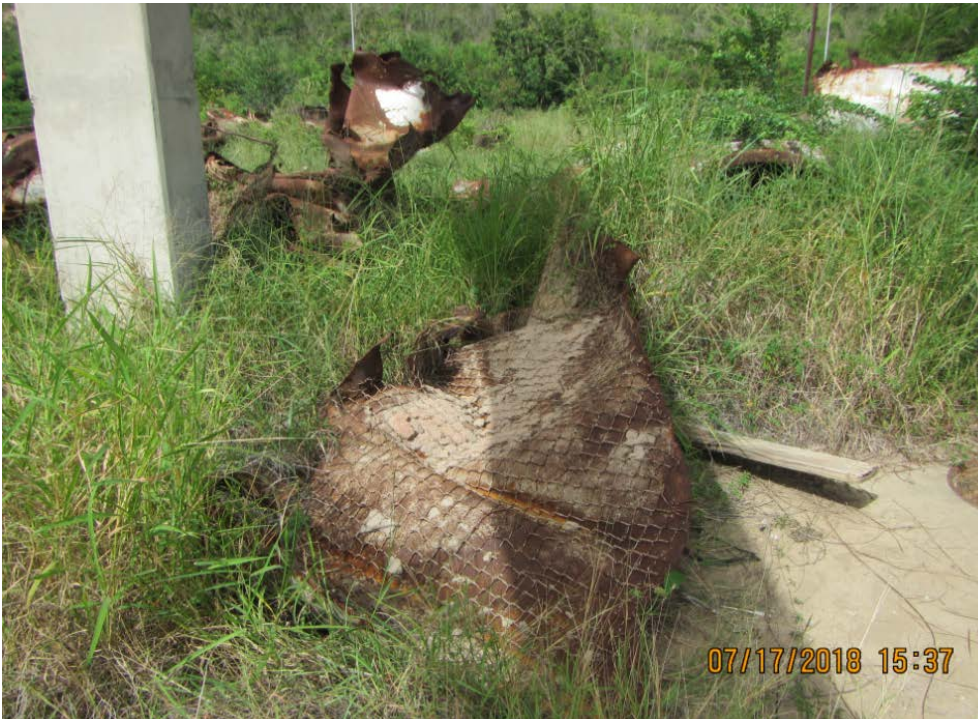
Figure 30, A piece of metal from the stack cut with the lining still in place. This was found next to an open drain hole.

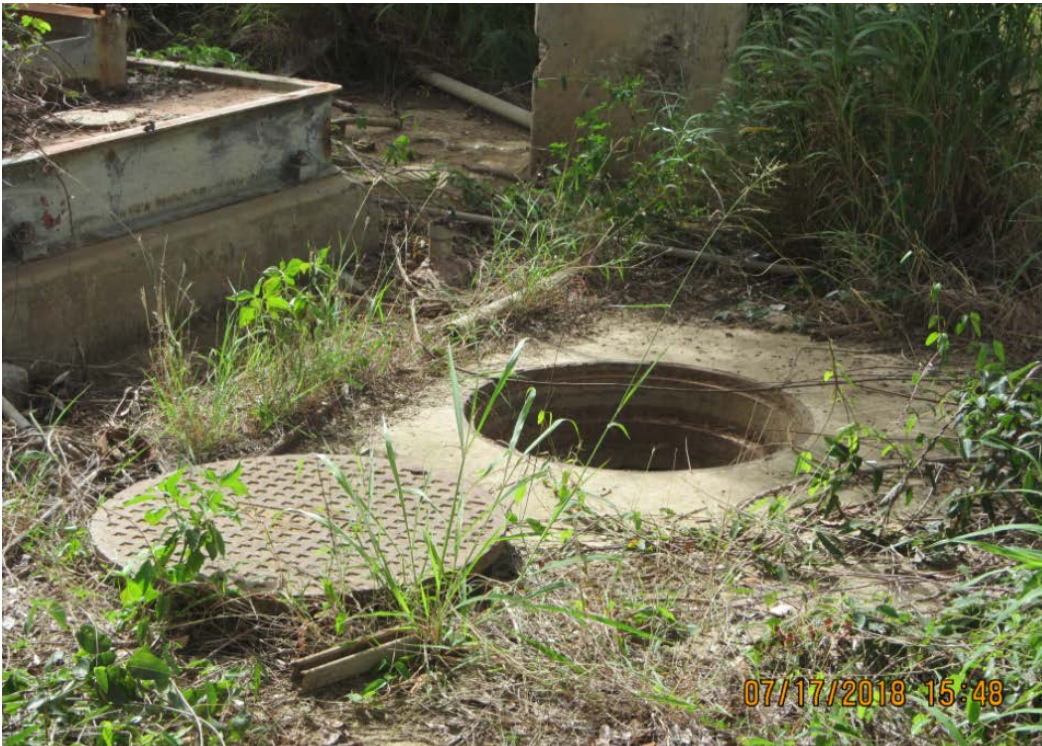
Figure 31, Found another open manhole. This one was harder to see from a distance because of the overgrown vegetation. Homeca staff stated that there were about 7 manholes that were open. He stated that superfund requested that they be open. Told them they need to closed now since superfund is done with their inspection because of the potential fall hazard.

While walking through this area, the inspector found 2 manholes that were opened. Mr. Feliciano stated that there are 7 manholes that are currently opened at the time of the inspection. The two manholes that were observed by the inspector appeared to be filled with water. The water was not clear so the inspector was unable to see if debris or insulation was under the water. Because of the debris and vegetation around the manholes, it did not appear safe to have these manholes kept open. The inspector requested that all manhole be closed to reduce risk of a person falling into one of these manholes.

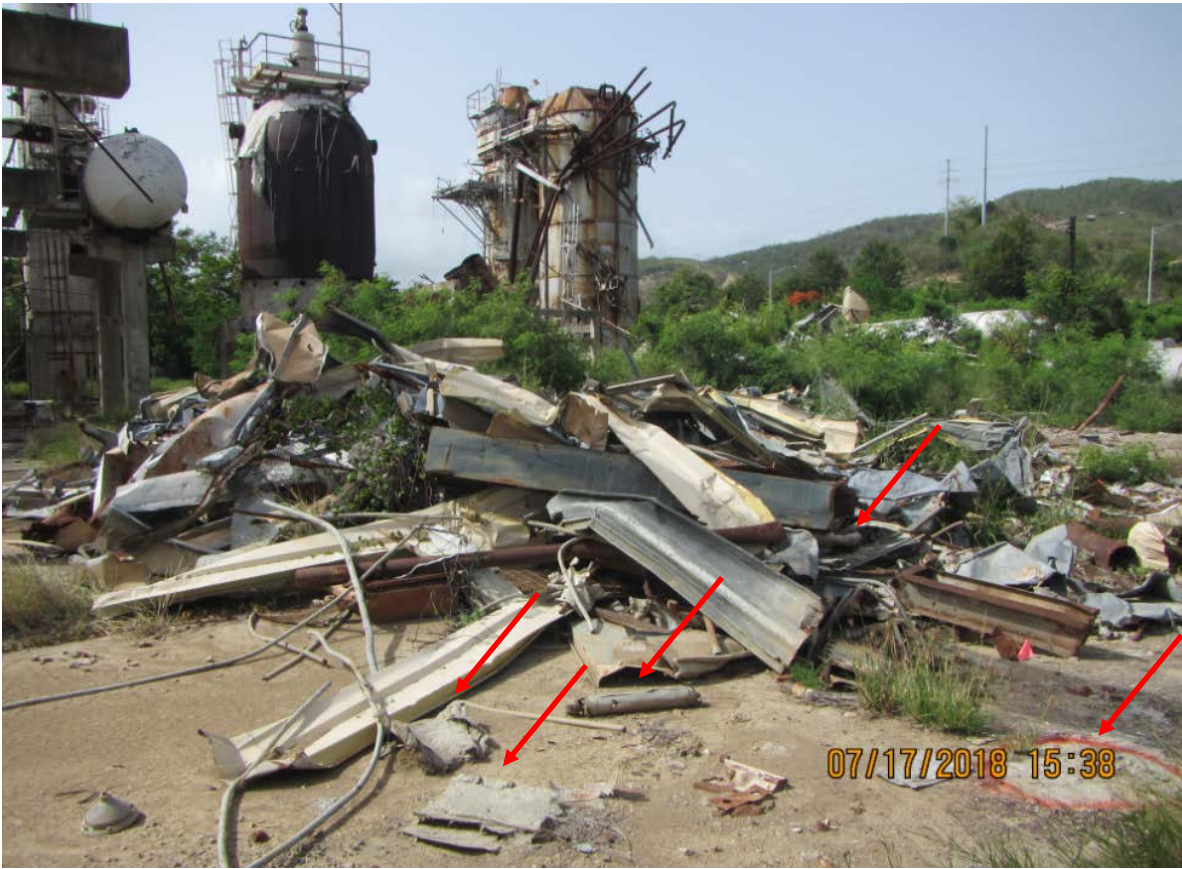
The inspector continued moving to the northern end of the Homeca work area (see figure 32). A large pile of metal was noted in front of the structures that were still standing. In and around the metal pile was insulation material that was readily identifiable (see figure 33 to 35). There is no indication of any wetting of the material.

Figure 33, Metal pile that appears to have insulation material mingled in it and around it.

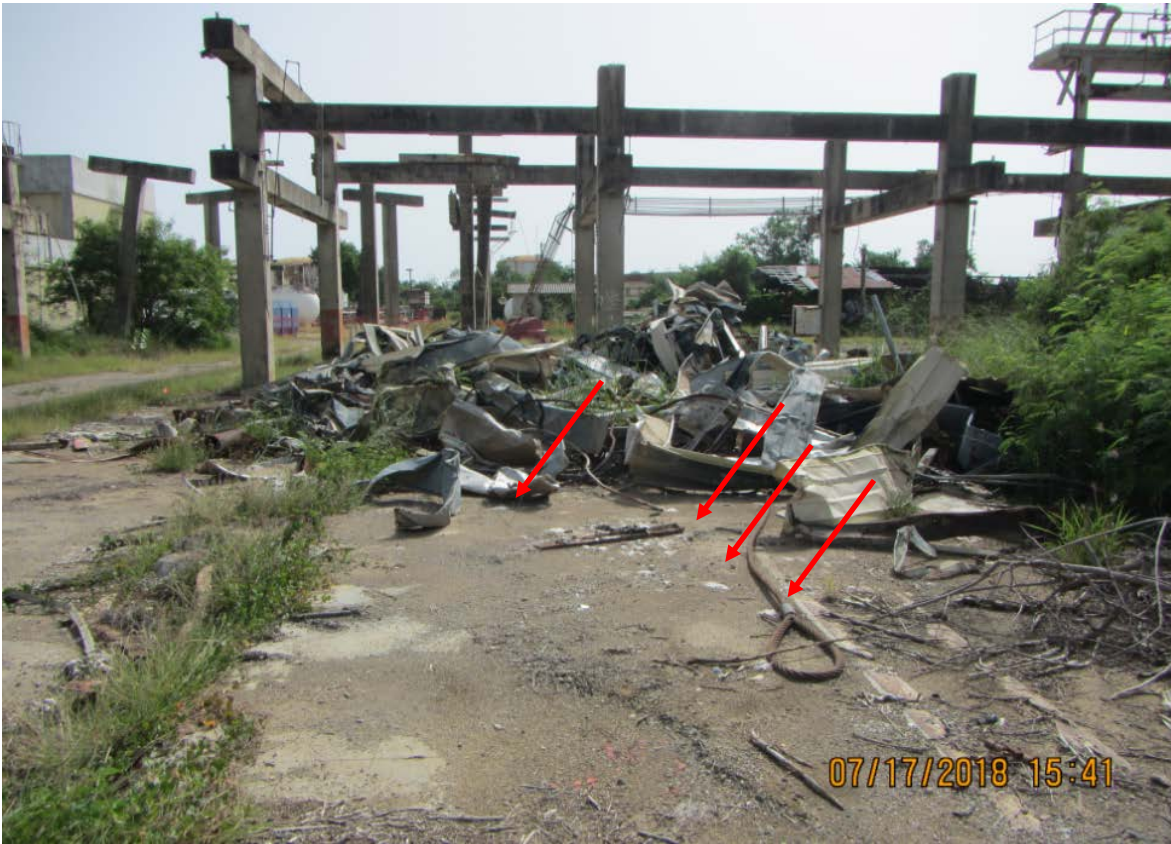
Figure 34, Another angle of pile in figure 33. Note the white spots in the front of the photo. These appear to be deteriorated insulation material.

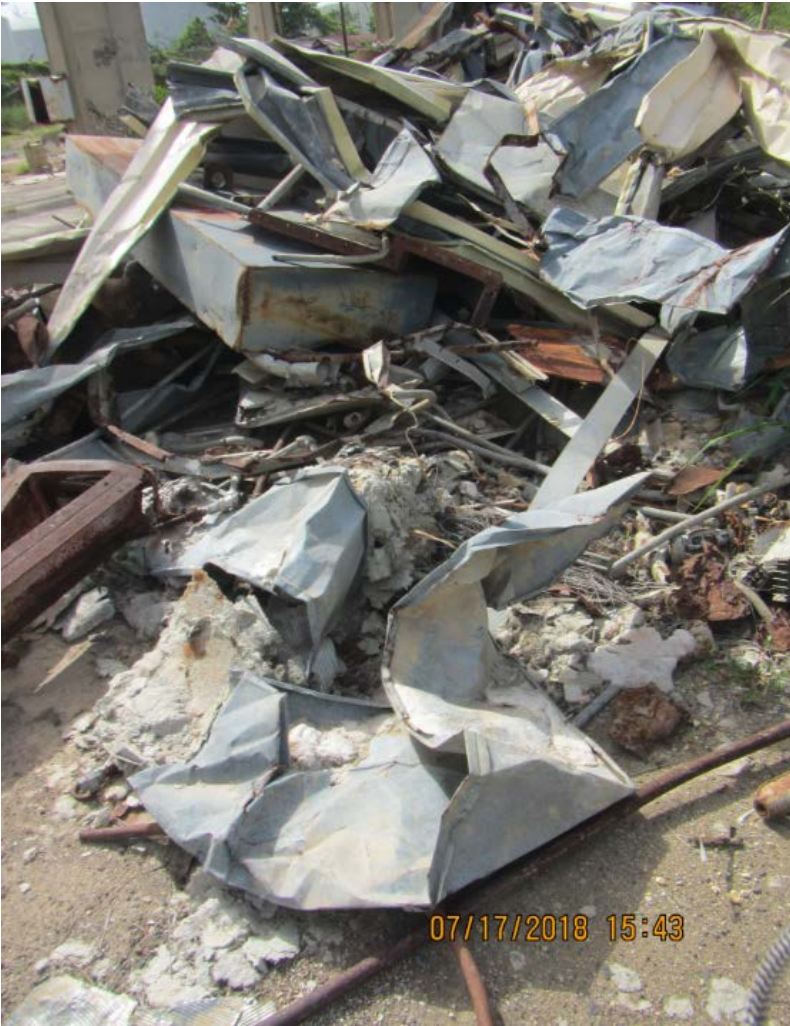
Figure 35, Another angle of pile in figure 34. Insulation material was piled onto of the debris.

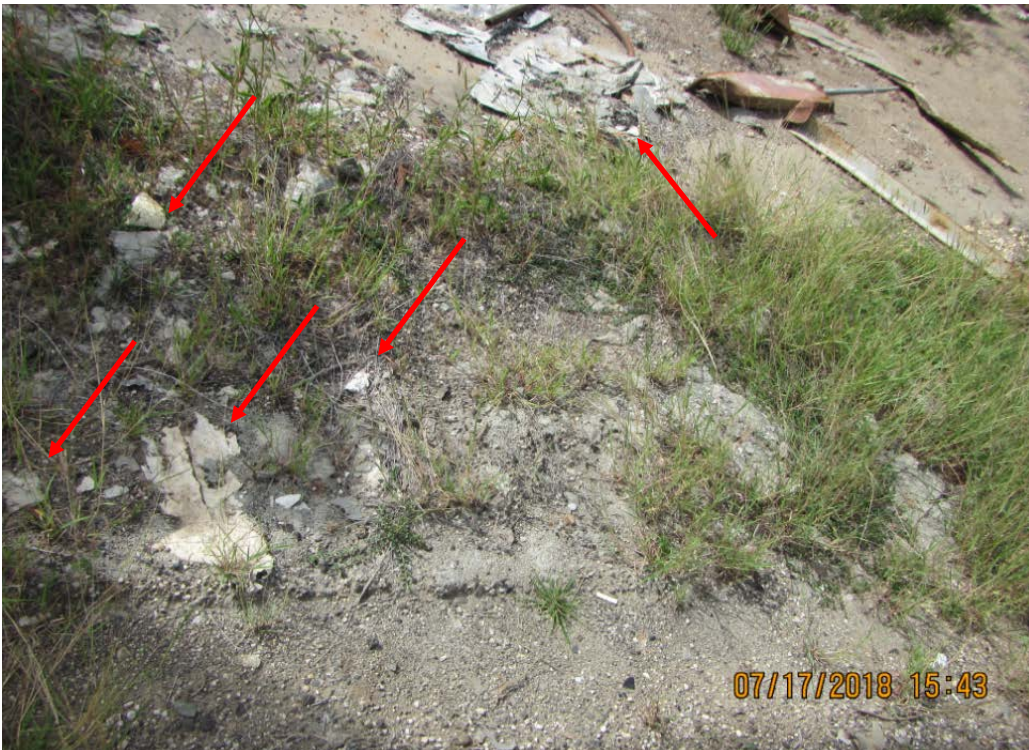
Pieces of insulation material was found scattered throughout the soil in this area (see figure 36). There were large standing structures located in this areas. These are structures that will be worked on in Phase two of the workplan. The inspector noted that the insulation material on these structures was in very poor condition (see figures 37-42). Insulation on the structures is openly exposed to the elements. Pipe insulation was found scattered on the ground throughout the area. (see figure 43).

Figure 36, Insulation material appears to be scattered in the soil around this area.
